Manhole Inspection Summary

Manhole # S13S__022MH

Location Address: **2900 Cowan Ave.**

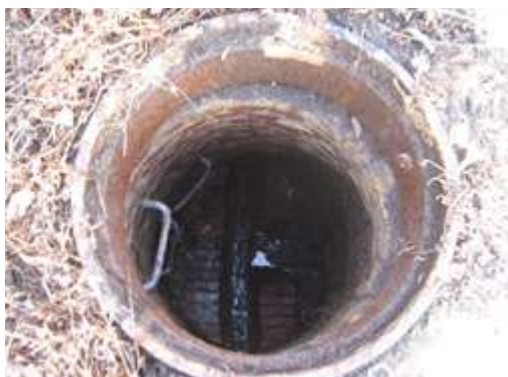
Defect 5

Condition: ☐ Sound ☐ Cracked ☒ **Root Intrusion** ☐ Loose Brick ☐ Deteriorated

Infiltration: ☐ None ☐ Joint ☐ Cracks ☐ Mortar ☒ **Roots** ☐ Wall

Chimney Root Infiltration, Frame Offset

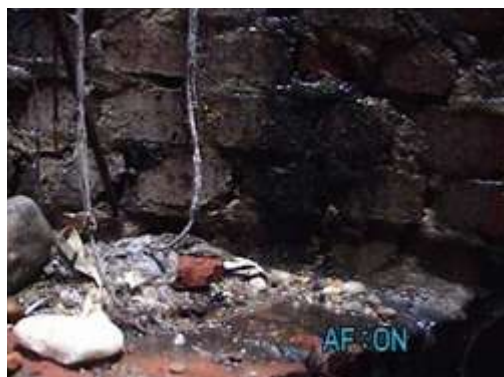
Defect 3

Infiltration: ☐ None ☐ Joint ☐ Cracks ☐ Mortar ☐ Roots ☒ **Wall**

barrel infiltration

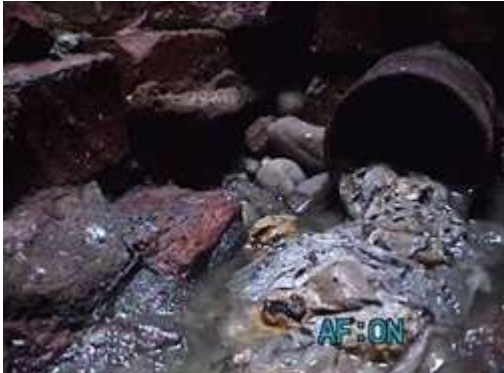
Defect 2

Condition: ☐ Sound ☐ Cracked ☐ Root Intrusion ☒ **Deteriorated** ☐ Leaks ☒ **Debris**

debris in channel, deteriorated channel

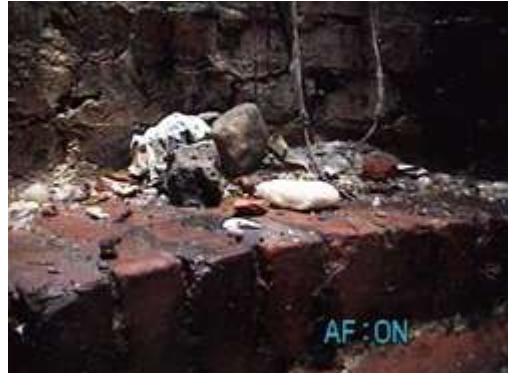
Defect 1

debris on the bench, roots in barrel

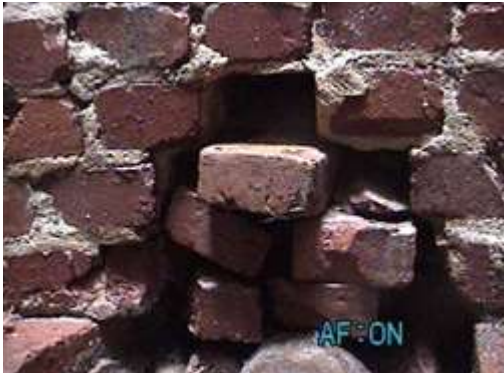
Defect 4

Condition: ☐ Sound ☒ **Cracked** ☒ **Root Intrusion** ☒ **Loose Brick** ☒ **Deteriorated**

Loose bricks in barrel around 3 Oclock pipe

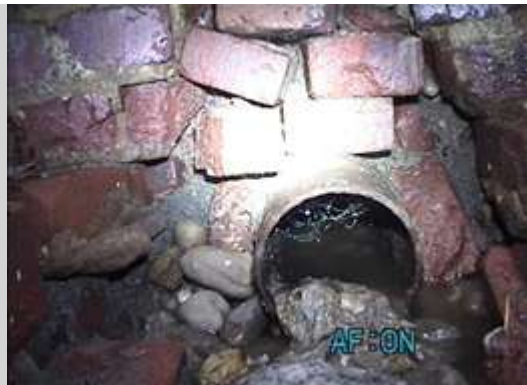
3 O'Clock Inflow

Pipe Height: **4.8** (in.) Rod and Bar (Angled)
Pipe Material: **Clay** ☐ Pipe Lined
Invert Depth: **8.60** (ft.) Flow Characteristics: **None**
Deposits: ☐ None ☐ Mud ☐ Sludge ☒ Debris ☐ Grease
Silt Depth: **3** (in.) Deposits Extent: **Medium**
Infiltration: **None** Pipe Seal Cond: **Sound**
